QA-307 Centreville National Bank Centreville Public

1903-1904

## INVENTORY FORM FOR STATE HISTORIC SITES SURVEY

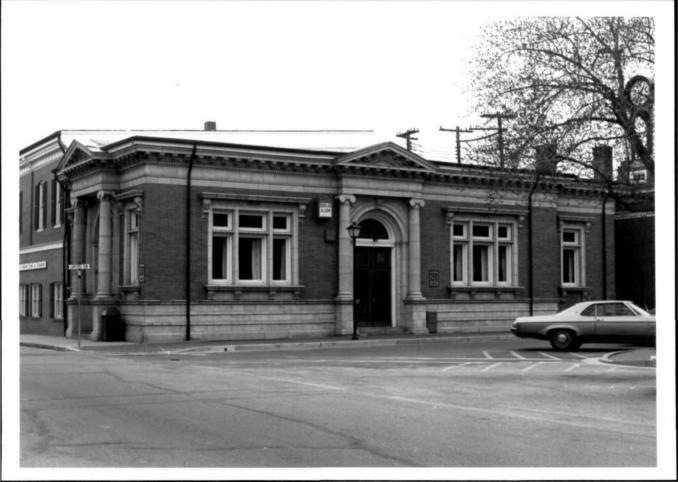
QA-307 Centreville National Bank Centreville, Maryland Orlando Ridout V 1980 View from North

The north facade, facing the Court House green, is essentially an expanded version of the east facade. The principal part of the north facade is three bays long, with an equally grand entrance in the center bay, flanked by large triple windows to either side. At the west end of the building, a fourth bay is set back about two feet from the principal plane of the building, housing the office of the bank president. The set-back delineates the separation of public part of the building from the more private office space. A single large

The decorative composition and detailing of the north facade are essentially identical to the east wall. The double doors are not set back in an arched recess and the windows are larger, but the pedimented entrance, the granite foundation, Roman brick walls and elaborate stone cornice all mirror the Commerce Street facade.

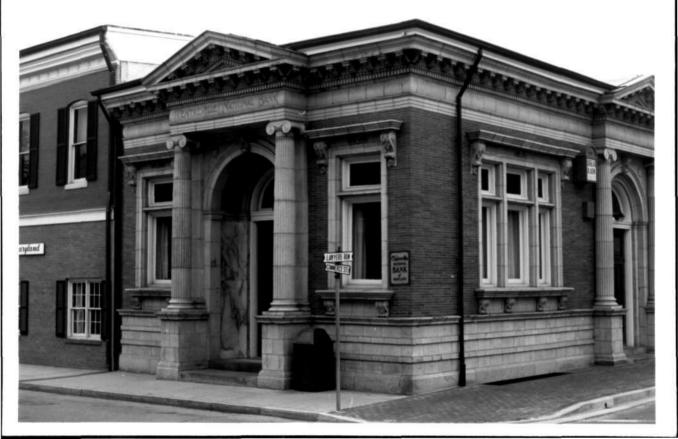
QA-307 Centreville National Bank Centreville, Maryland Orlando Ridout V 1980 View from Northeast

The east facade, facing South Commerce Street, is dominated by an elaborate, decorative entrance in the center of this elevation. Large double doors are recessed in an arched opening set off by fluted Ionic columns resting on high bases and supporting an ornate, projecting pediment. Large windows flank the center bay. These have a single light with a leaded transom set in a molded granite frame with molded sill and lintel supported by carved floral brackets. The wall is laid in stretcher bond Roman brick of a rust brown color with flecks

of dark above a granite foundation with a simple beveled water table. A broad, refined cornice is carried across the upper part of the facade. The cornice is a lighter stone, elaborately molded with a complex crown mold, carved brackets, and courses of egg-and-dart and dentil block moldings above a cushion frieze and rabbeted fascia. The name of the bank is cut into the frieze of the projecting pediment over the door. The decorative stonework is of very high quality in both design and workmanship and combines extremely well with the richly colored Roman brick. The entrance is further enriched with a paneled stone soffit, yellow marble jambs, and a leaded transom above the double doors.

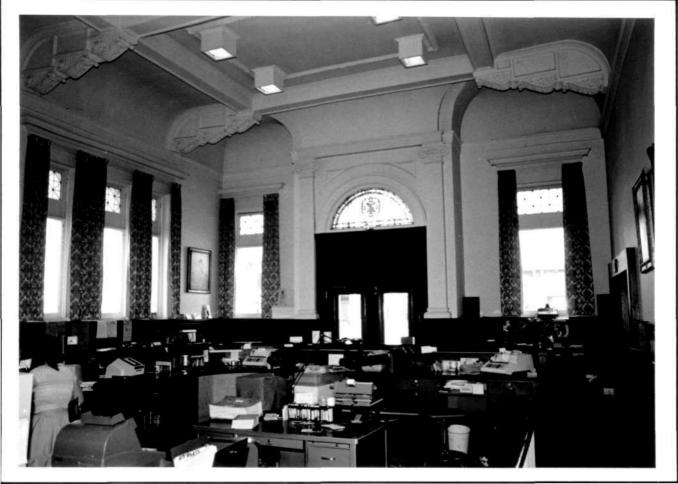
QA-307 Centreville National Bank Centreville, Maryland Orlando Ridout V 1980 Interior, facing East

The interior of the bank is composed of a large rectangular public area to the east, a large vault at the west end of the public area, and the president's office to the west. The public area is divided by a long L shaped teller's counter running parallel to the east and north walls, with desks and a stair to the cellar occupying the area enclosed behind the counter. A reception area along the north side of the vault leads to the president's office.

The main banking room is also paneled on the north and east walls. The ceiling is coffered with decorative plaster molding in the large inset panels and large molded brackets along the walls forming the terminus of each rib of the coffering. The north and east doors are flanked by Ionic pilasters. Other details of interest include the classical frieze with egg-and-dart molding and surmounted by a clock set in a heavily carved frame above the door to the vault and the glazed brick or tile facing on the vault.
